## TechData Sheet

TDS-2025-SHR

### Polymer Composite Utility Pipe Hangers

Highlights and Recommendations from NFESC Studies

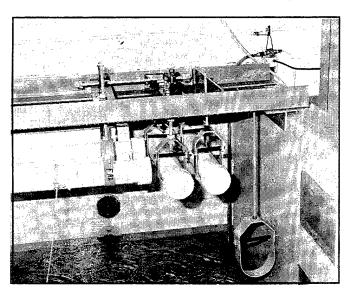
room contains a 5-foot deep concrete tank where water or recirculating seawater can be pumped in. The hangers were attached to concrete slabs placed on bracket supports suspended over the pool (as shown in Figure 3). Each pipe was held by two composite hangers. The composite hangers included materials made of several reinforced plastics.

Figure 3. Tests on composite (yellow) and metal pipe hangers at NFESC seawater tank (environmental chamber).

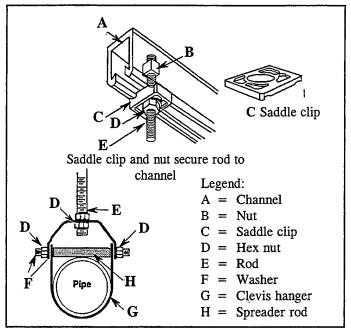
Figure 4. Pipe hangers.

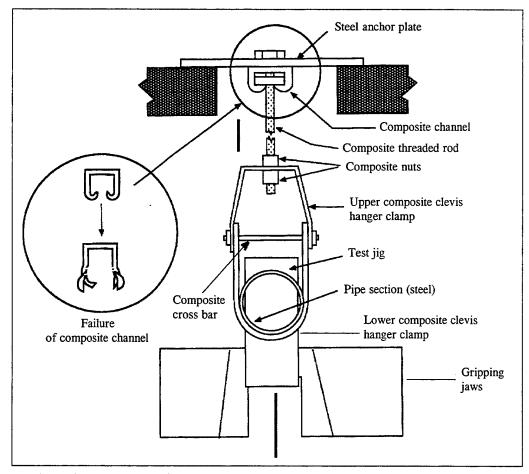
The results from Table 3 (and shown in Figure 9) are tensile tests for the entire hanger and channel system. The failure always occurred in the lips of the channel, which hold the rod and nut of the composite hangers, that is, the hangers did not break. However, it can be seen that the type of material used for the channel does matter when selecting the strongest system. According to the tensile test strength for Strut 1, which is a vinylester hanger, the channel strengths vary from Kynar®>polyester>polyvinyl chloride. The materials follow the same order for costs, that is Kynar® (\$80.00)> polyester (\$40.00)> polyvinyl chloride (\$26.00). The amount in parentheses is what we paid for each 10-foot length of channel.

Figure 9. Test assembly for polyester and vinylester clevis hangers (using a channel).

Although we did not perform long term weathering and tensile tests on the composite channel materials, it can be deduced from the present data that Kynar® is probably the strongest and most durable material, as well as the most expensive. PVC is the weakest and least durable, although the least expensive. Designers faced with balancing cost and durability may wish to consider using polyester channels, which are in the intermediate price and strength range.

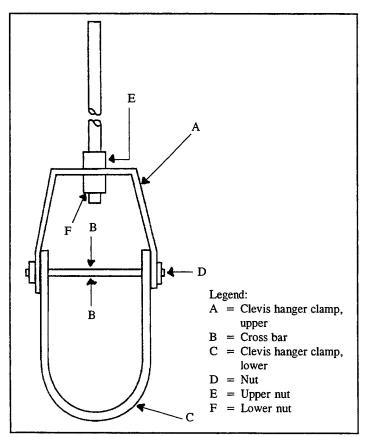
Figure 10. Failure points when composite hanger is subjected to high tensile testing.
